SPRING RIVER PARK AND ZOO

EXISTING CONDITIONS & DESIGN RECOMMENDATIONS

FINAL REPORT - JANUARY 2018

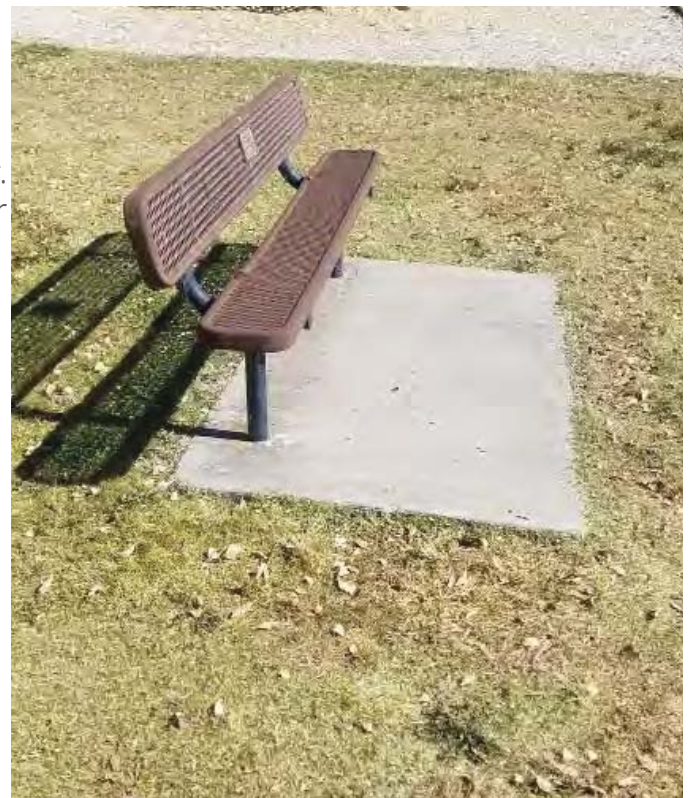
A concrete pad protects furnishings from turf maintenance equipment. If located next to a path, the pad would make the bench accessible.

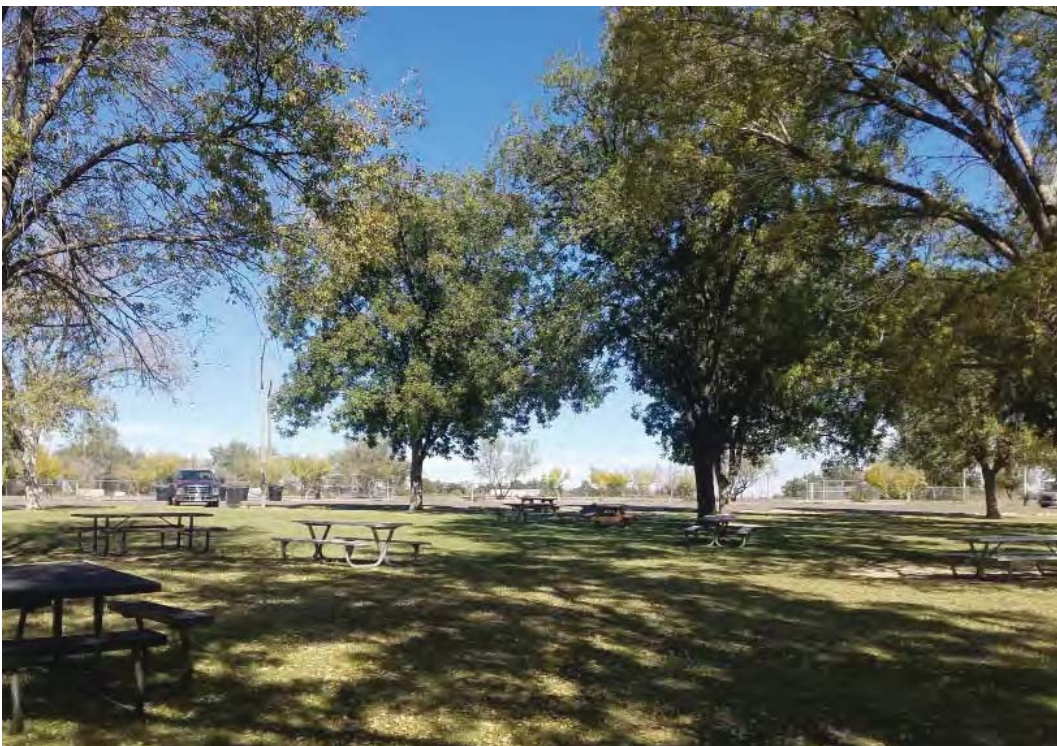
The park has a beautiful tree canopy creating dense shade. Plant the next generation of trees now, so that they are established when the existing mature trees decline.

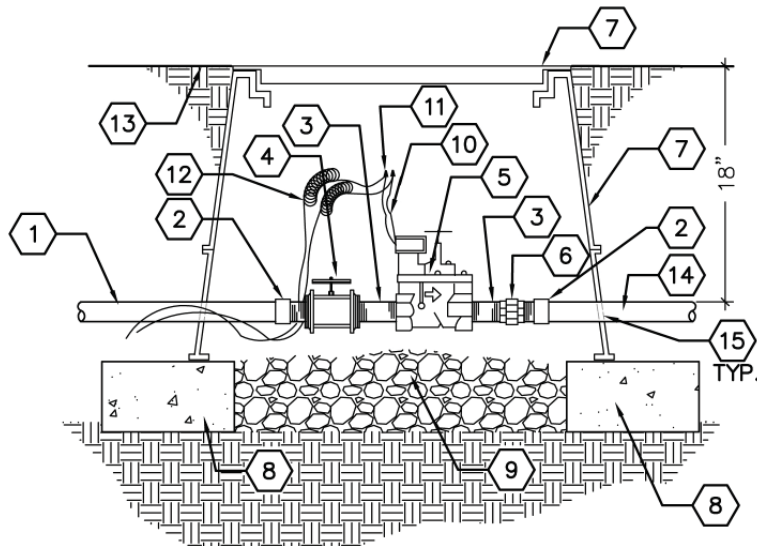
This valve installation features an oversized box, allowing maintenance personnel to maneuver and make repairs without removing the entire box. An isolation valve is located upstream of the valve, allowing the irrigation zone to be shut off manually without disrupting the entire system. The valve is raised above the soil, making maintenance easier and keeping the valve away from debris.
